Preliminary Engineering Report Water and Wastewater Facilities

Canton, MN

March 2022

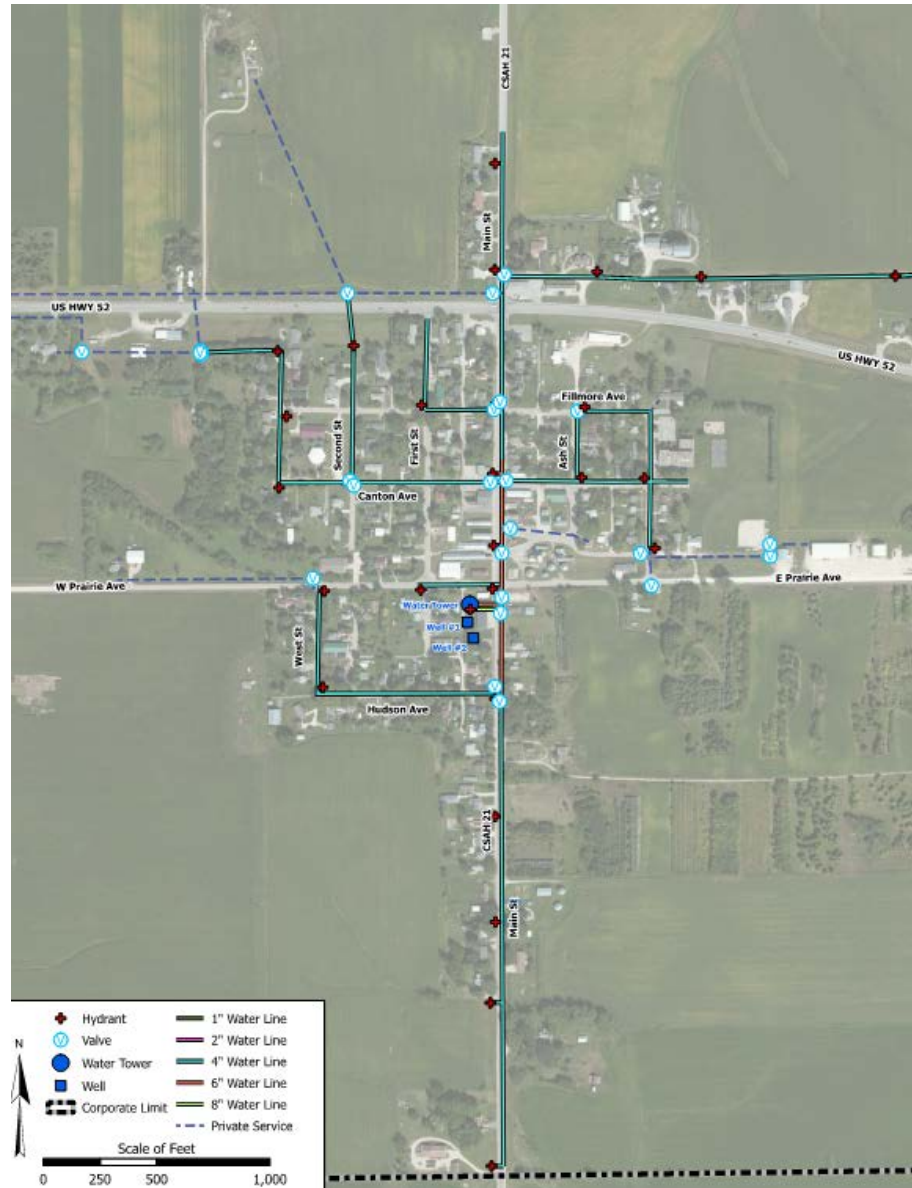
Water System

- ▶ Distribution System
 - Aging pipes (1910s)
 - Lead joints
- ▶ Well #1
 - Built 1918
 - Fluoride treatment
 - Pump replaced 2021
- ▶ Well #2
 - Built 1983
 - Fluoride treatment
- ▶ Water Tower
 - Built 1914
 - Exterior painted in 2017

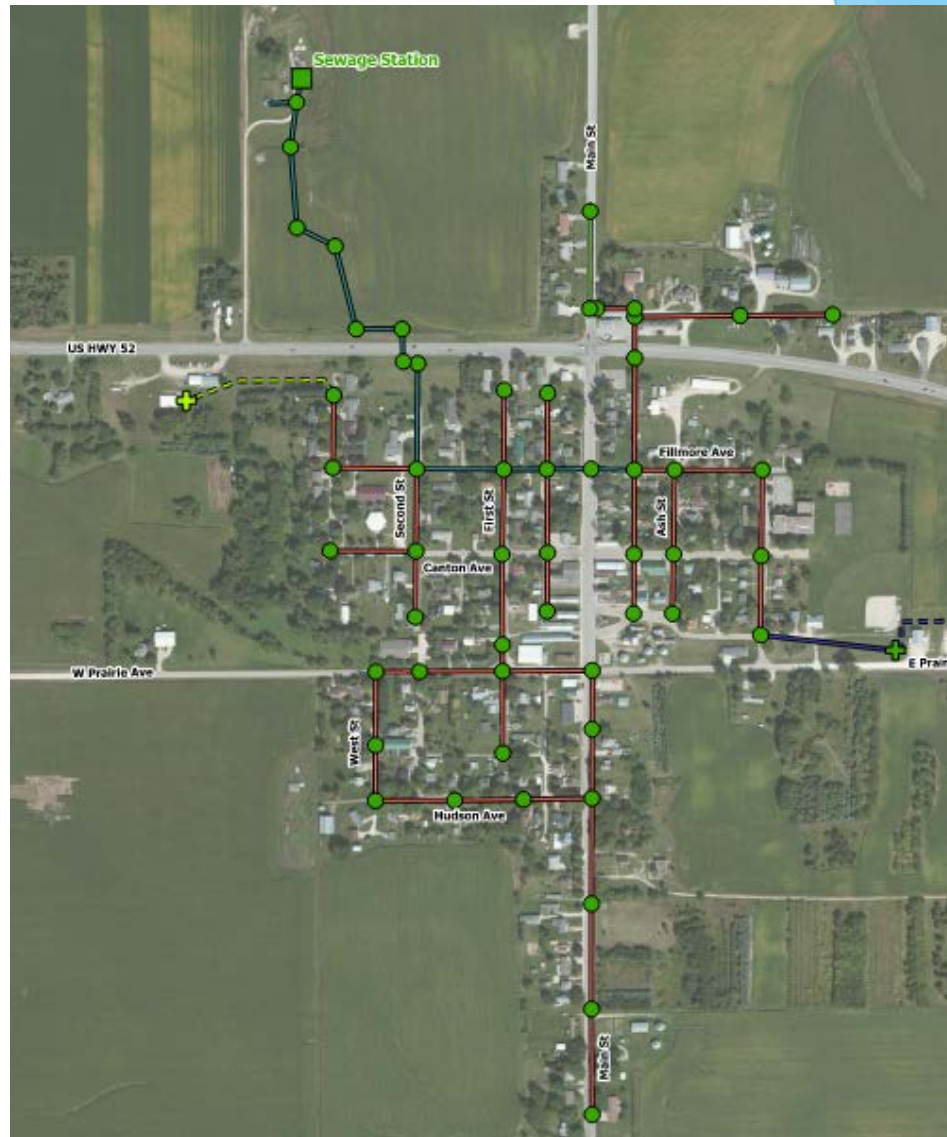
Wastewater System

- ▶ Collection System
 - Aging pipes (1950s)
- ▶ Treatment Plant
 - Built 1960, upgraded 2003
 - Oxidation ditch
 - UV disinfection
 - Sludge digester/storage tank

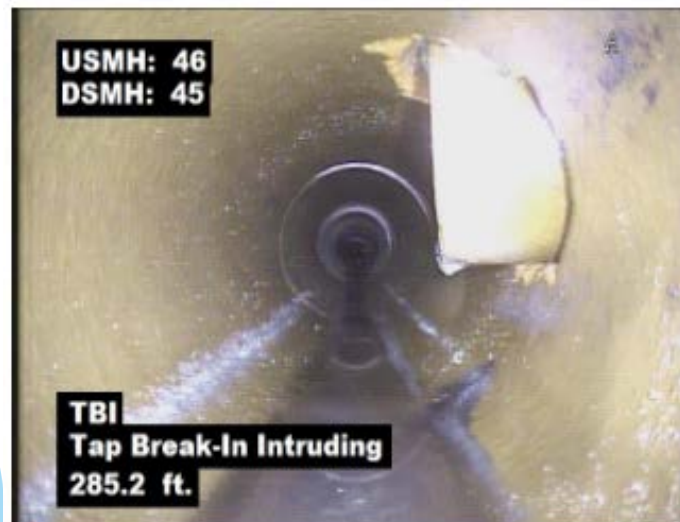
Main Street & Fillmore Ave

Distance: 285.2 ft. Grade: 5
Condition: Tap Break-In Intruding
Remarks: N/A

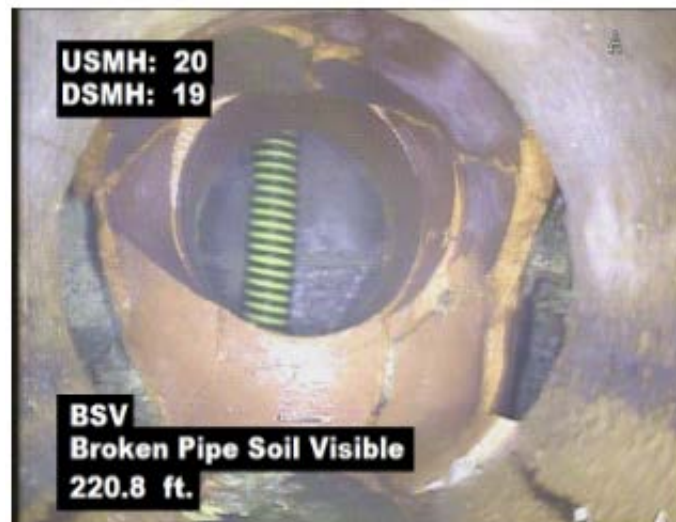
Ash Street & Canton Ave

Distance: 220.8 ft. Grade: 5
Condition: Broken Pipe Soil Visible
Remarks: N/A

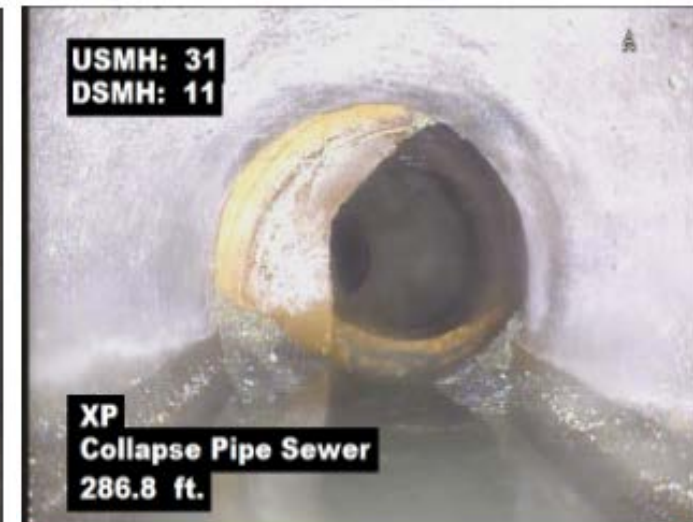
1st Street & Fillmore Ave

Distance: 286.8 ft. Grade: 5
Condition: Collapse Pipe Sewer
Remarks: SECTION OF PIPE HAS BROKEN AND COLLAPSE
